Automotive Safety Engineering Pty Ltd

VIBRATION DURABILITY TEST TO WHEEL COVERS

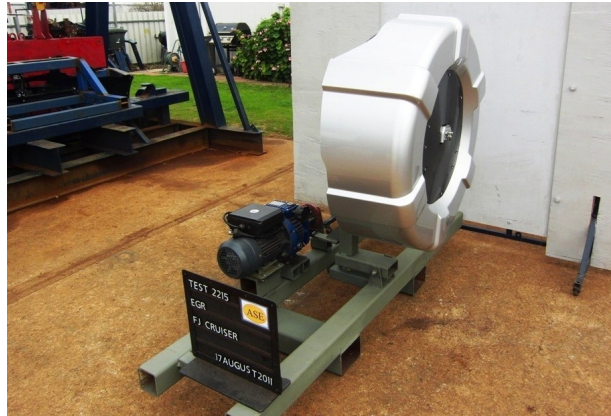
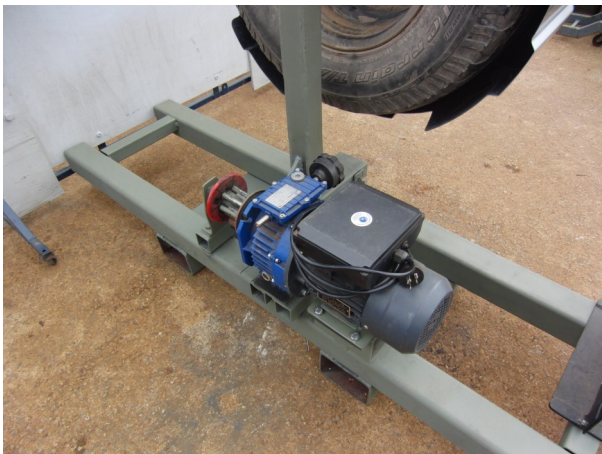
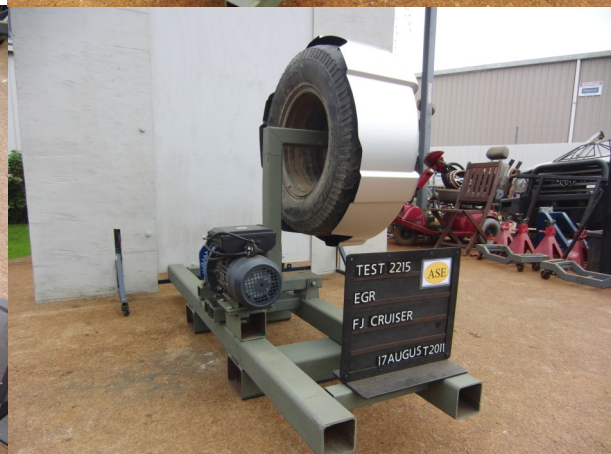
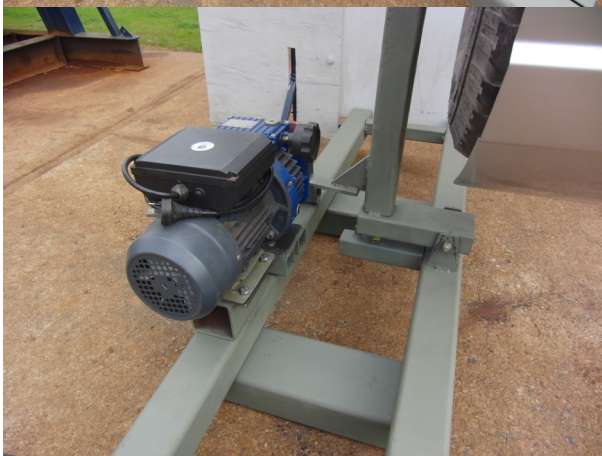
At ASE we perform vibration durability tests to wheel covers according to TSM0502G Rev 10 Trunk Room test conditions. This means that ASE uses a frequency of 11Hz, a vertical vibration acceleration of 59.8m/s^2 , a lateral vibration acceleration of 36.3m/s^2 , a duration of 3,000,000 cycles (76.76h) and at a normal temperature.

The objective for this test is to identify possible fatigue and resonance problems that might affect a structural integrity of the tested structure.
